SECURIKEY®

Possible Secu A and B installation issues

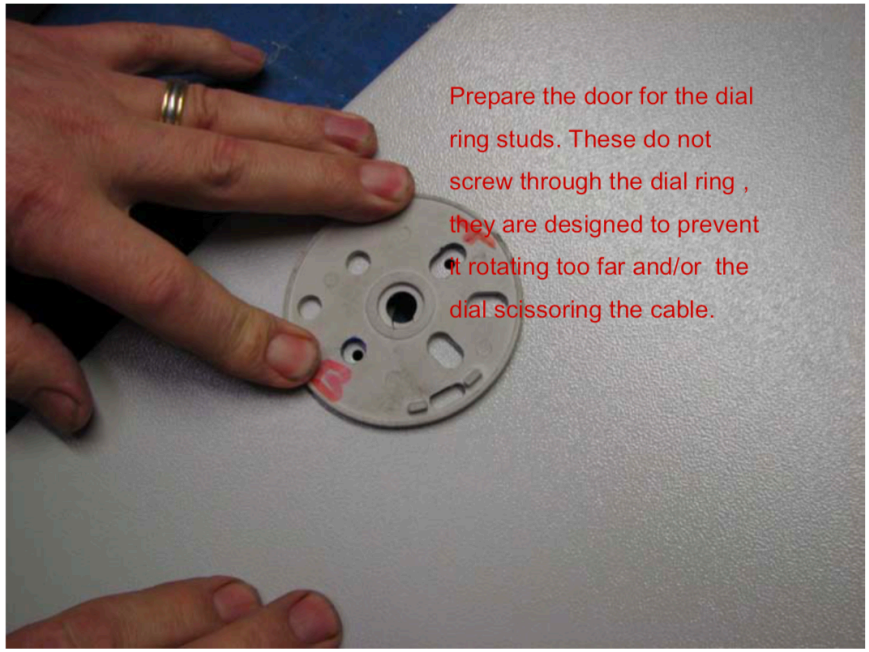
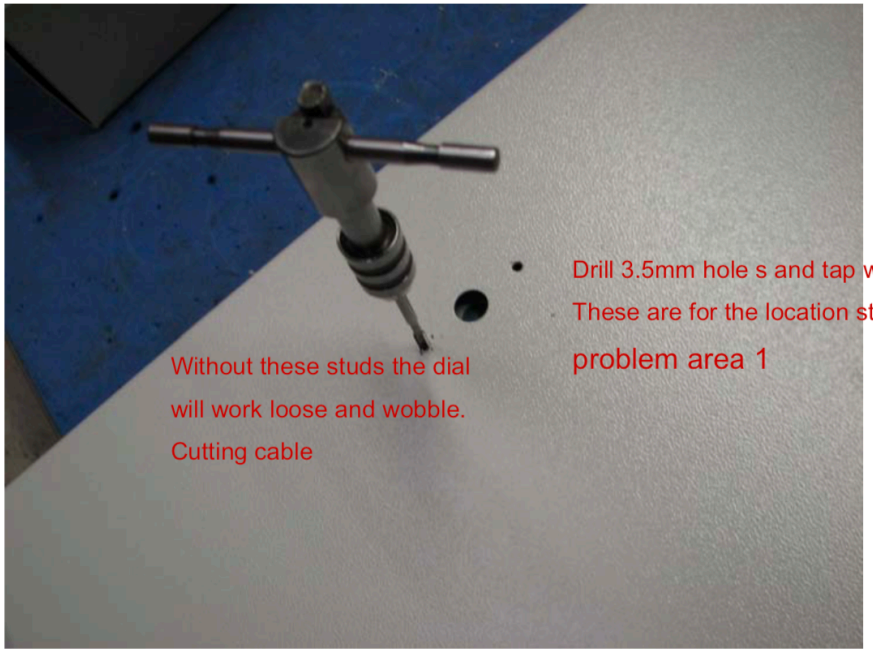
All locks have some areas of possible problem.
The 2 areas with the Secu locks are ;

1. **If the location screws are not used for the dial ring the sticky pads (now reduced in size and only for location purposes) work loose and cause the dial to wobble and shear the cable at this point.**
2. **The cable becomes trapped in between the dial ring and key pad , the screw is tightened in the spindle and this crushes the cable causing long term cable sheer or intermittent faults. Only evident during pro-longed use**

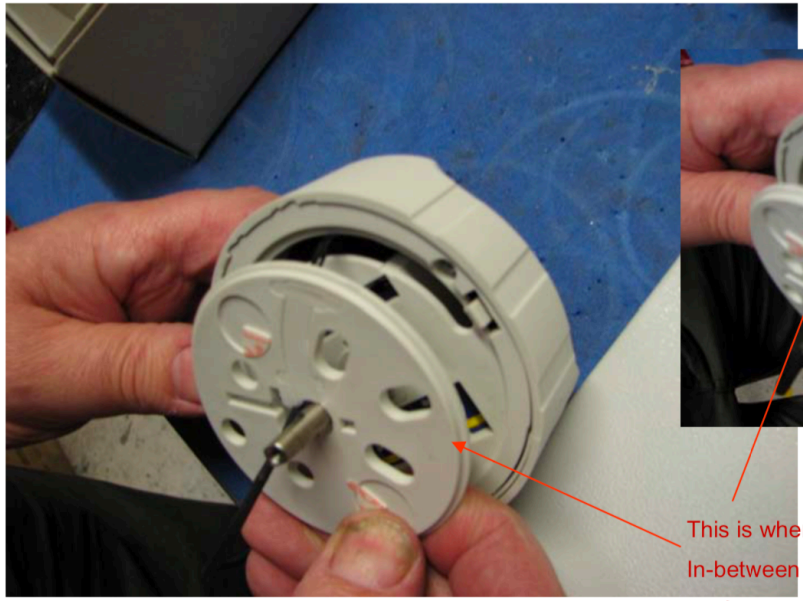
This is where it gets trapped if your not careful, In-between case and dial ring. Then the turning motion acts like a scissor action over time.

Rotate to ensure free movement and nothing is trapped

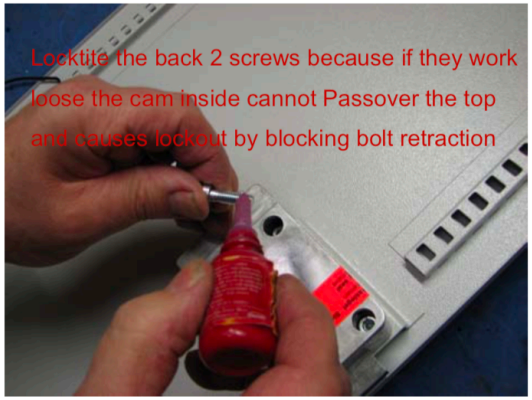
Locktite the back 2 screws because if they work loose the cam inside cannot Passover the top and causes lockout by blocking bolt retraction
